Report of the Panel to Review the V-22 Program

April 2001

SUBJECT: Report of the Panel to Review the V-22 Program

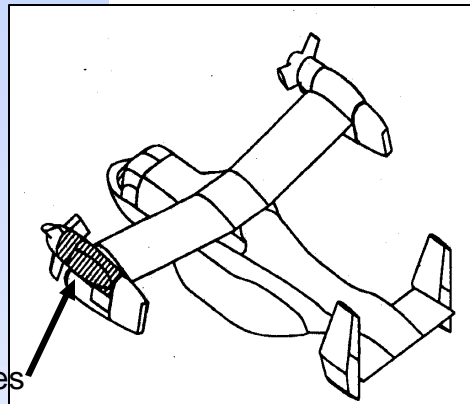
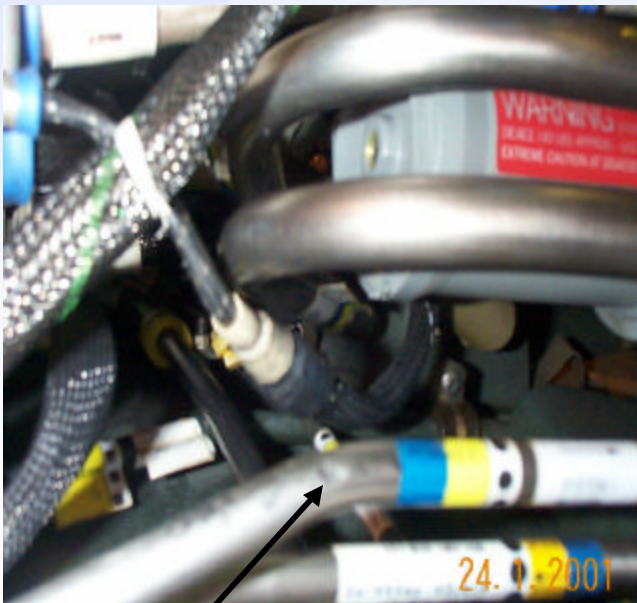
#1 Readiness Driver Hydraulic Lines

Location of
Chafed Tubes

Chafing

Recommendation: Develop techniques, tools, and methods for timely identification of hydraulic-line chafing.

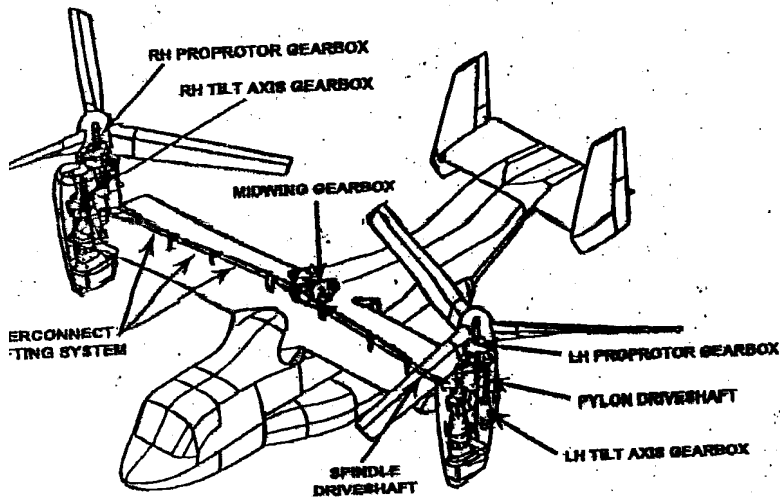
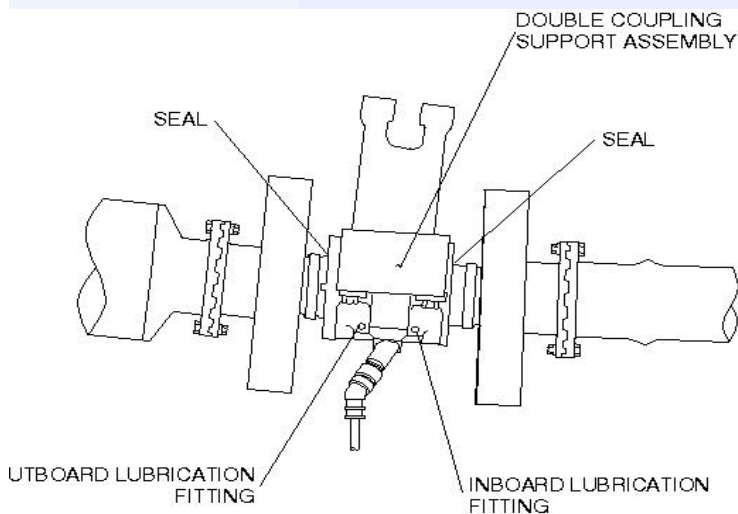
DRIVE TRAIN INSTALLATION

- Failure of ICDS coupling in flight. A/C landed safely. VSLED system failed to detect failure. Investigation revealed a loose retainer assembly caused the lock ring to break, allowing the curvic joint to separate.
- EI indicated need for 3 changes: increased torque, removal of Dry Film Lubricant, Improved Lock Ring design

- Engineering Change Proposal (ECP) has been approved to incorporate changes and modify fielded aircraft. ECD fleet incorp expected by 7/01. Estimated TAT for fleet couplings is now 6 weeks from original estimate of 2 weeks.
- ICDS from 165433, 165435, & 165441 shipped to Bell for incorp. Mod complete and shipset for 165441 received by fleet. 2nd shipset to Fleet ECD: 4/24/01.

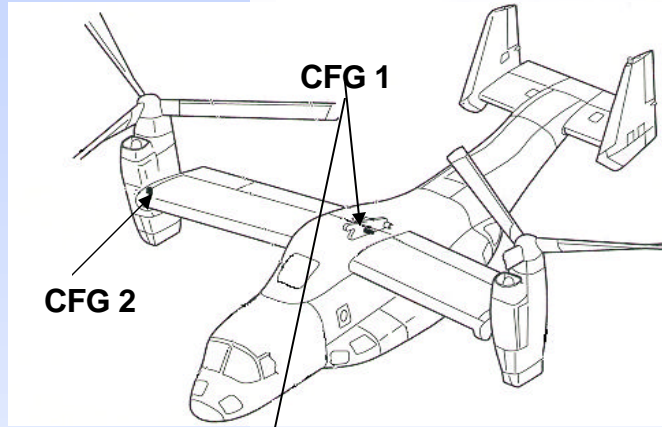
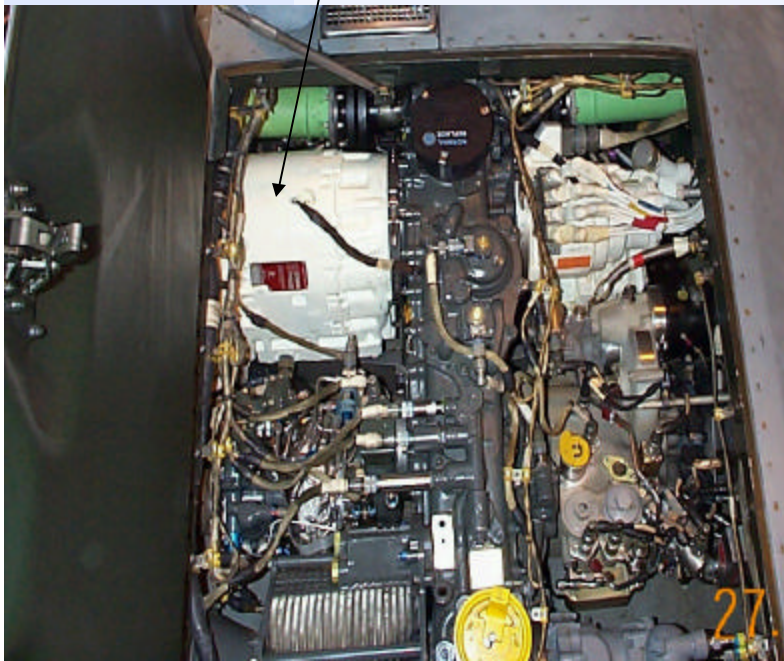
Constant Frequency Generator #1

Looking forward above MWGB

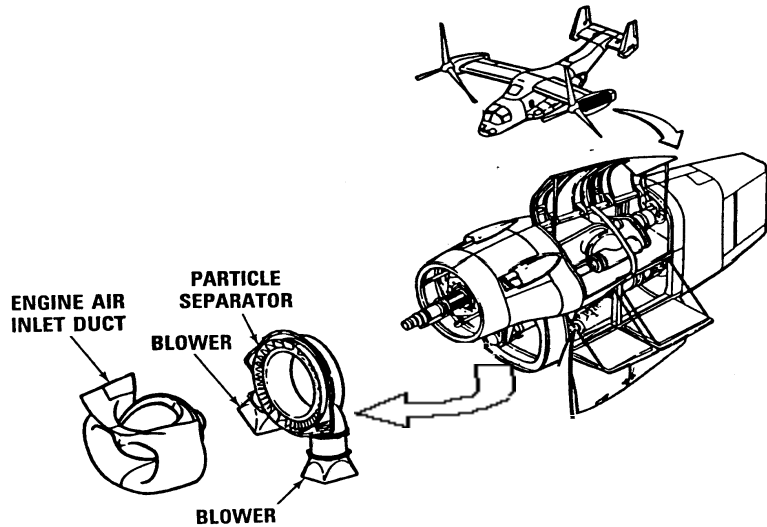
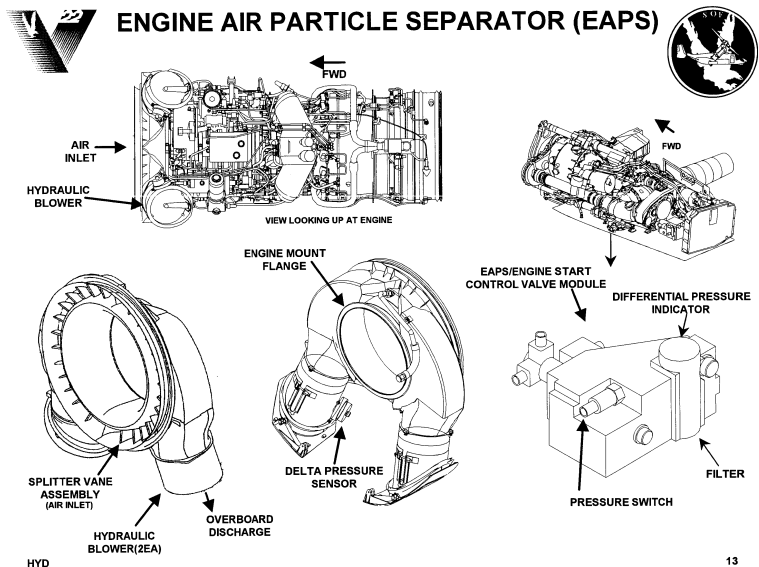
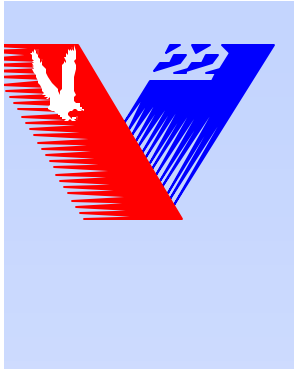
#4 Readiness Driver EAPS Overview

- High frequency of EAPS failure warnings
- Low reliability of EAPS blowers
- High frequency of shaft seal leakage

- Vendor has modified blowers to the “B” model to improve reliability
- “B” model is installed on fleet acft via AVB-908
- Pneumatic pressure switches to be replaced with hydraulic pressure switches (ECP V-22-0187)
- Shaft seal design improvements suggested in new “C” model, still under consideration

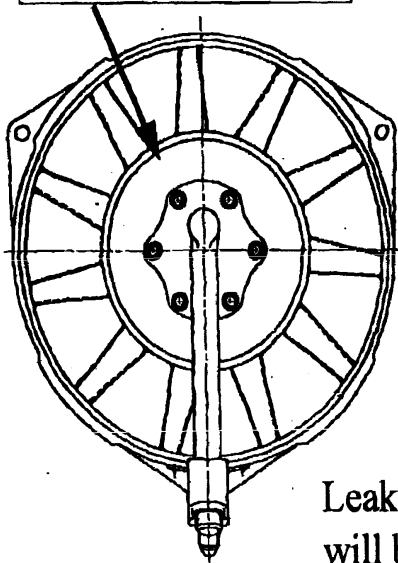
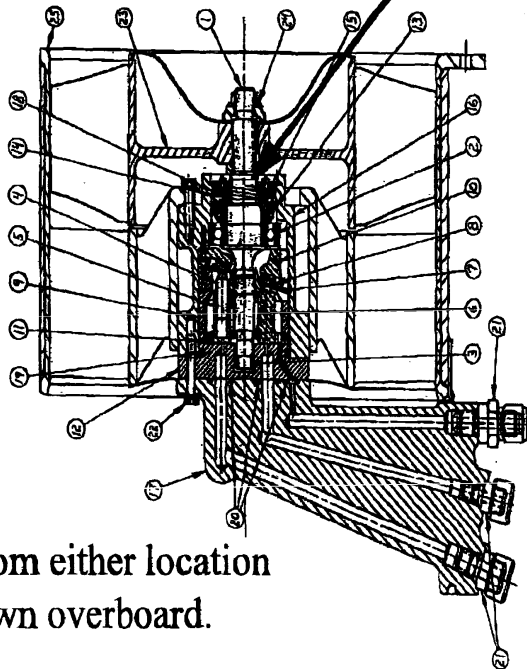
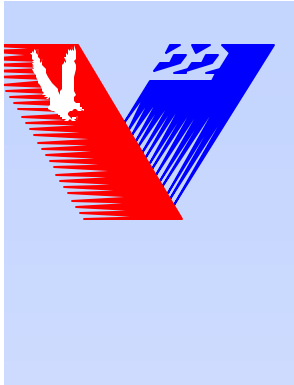
#4 Readiness Driver EAPS Status

Shaft seal leakage
can exit blower
from cover plate

Shaft Seal Leakage

Leakage from either location
will be blown overboard.

- Accessory Bulletin (AYB) 908 to replace unmodified blowers with reworked blowers that serial numbers end with "B" suffix has been released. AYB-908 complete on A/C 165433, 165435, 165437, 165438, 165439, 165441, 165442
- Awaiting Bell-Boeing proposal for funding and approval of ECP V-22-0187
- Proposed "C" shaft seal design change waiting authorization

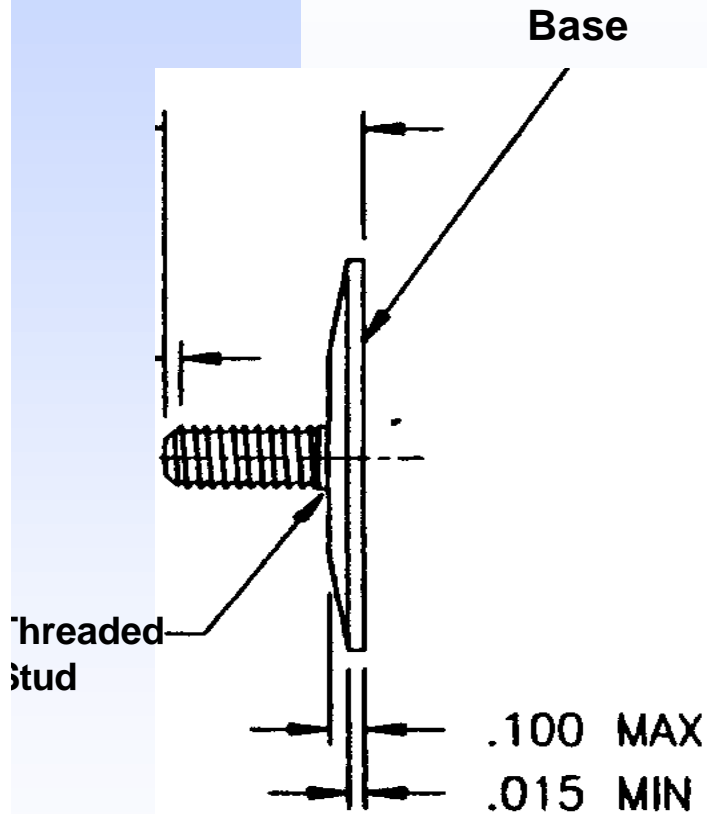
5 Readiness Driver Clickstuds

- Clickstuds bonded to the structure to secure various items on the airframe (ie., acoustic blankets, wire bundles, etc.) are debonding from structure.

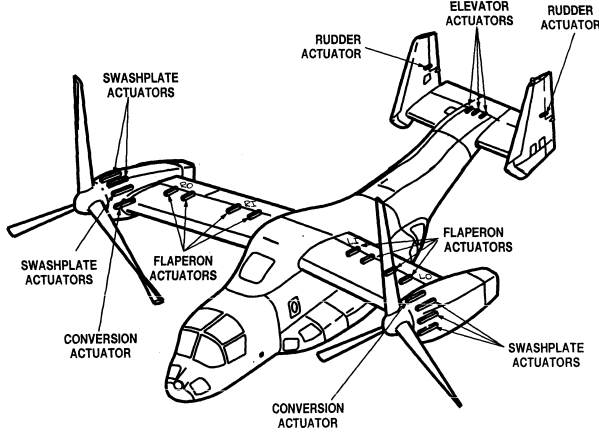
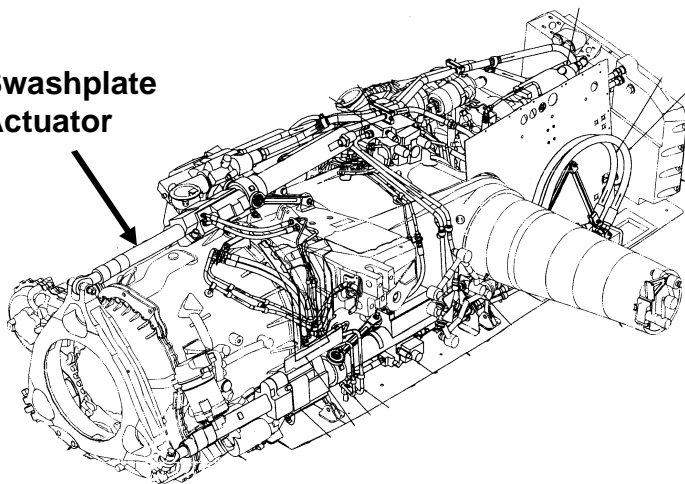
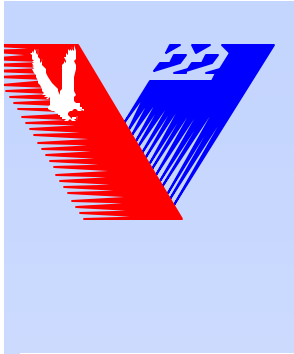
FLIGHT CONTROL ACTUATORS

- Swashplate Actuators experiencing hydraulic leaks and PFBIT failures

Swashplate Actuator

- CCP 10716 authorized incorporation of improved -115 actuators for Lot 4 delivery
- PFBIT software change has been incorporated into FCC software version 12 and retrofit into version 11.3

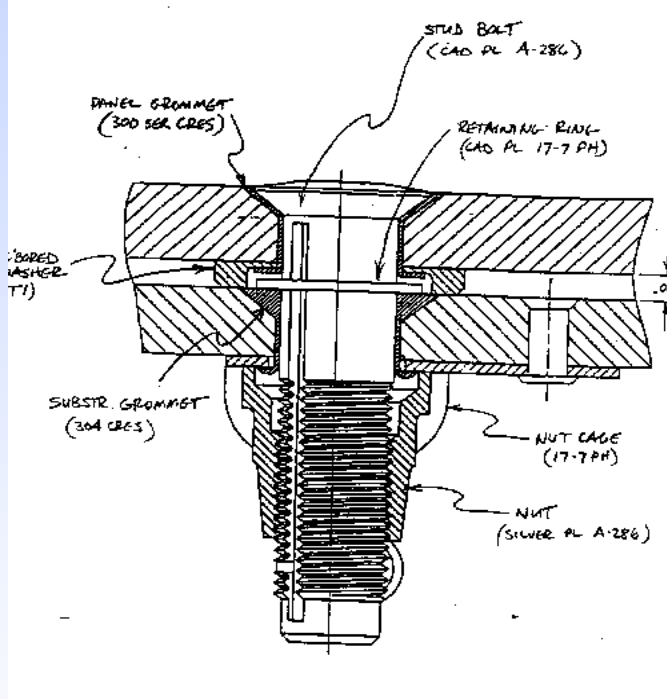
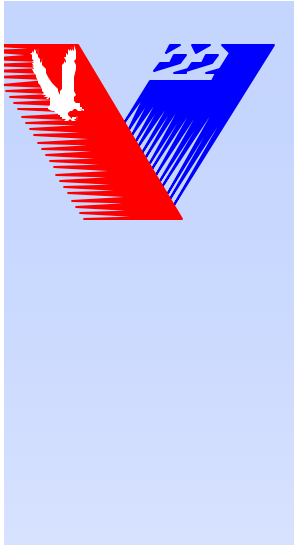
#7 Readiness Driver Mini-Mark IV Fasteners

Typical Mini-Mark IV

- OEM and Bell/Boeing studies on-going
- SBIR in Phase I
- Reviewing alternatives from 01Mar01 mtg w/ Fairchild
- Fairchild, Bell-Boeing, FST and VMMT-204 met on 11 Apr 01 at Bell.

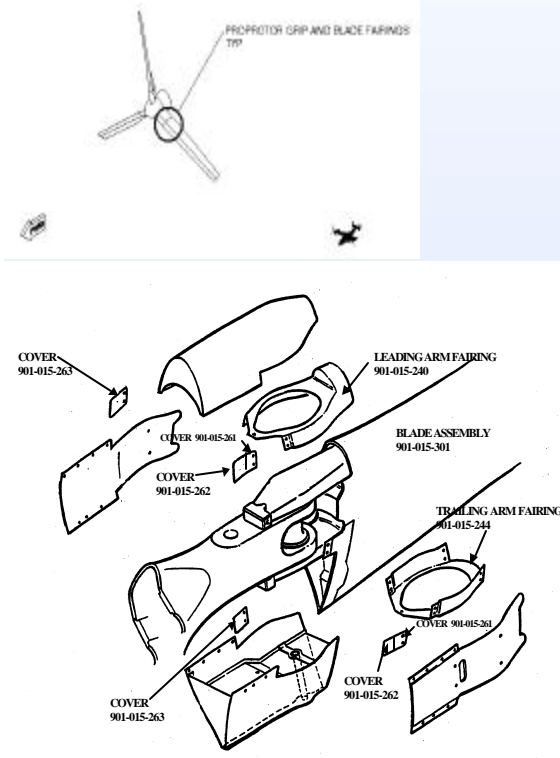
#8 Readiness Driver Blade Fold Fairings

- Engineering investigations have identified the most likely cause of cracked fairings to be interference that occurs during the fold cycle.
- Bell PCA approved.
- ECP pending.
- Fairing Trim data available, waiting for Bell to provide trim data for Blade.
- Bulletin for fairing trim is in final coordination.

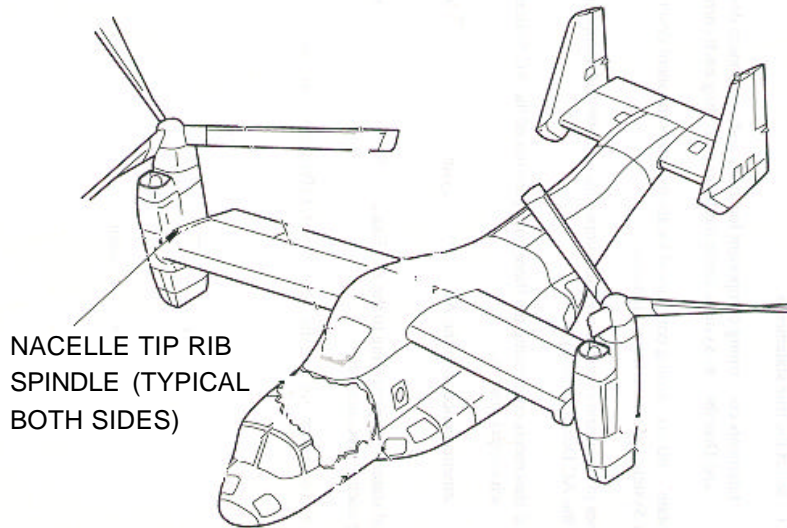
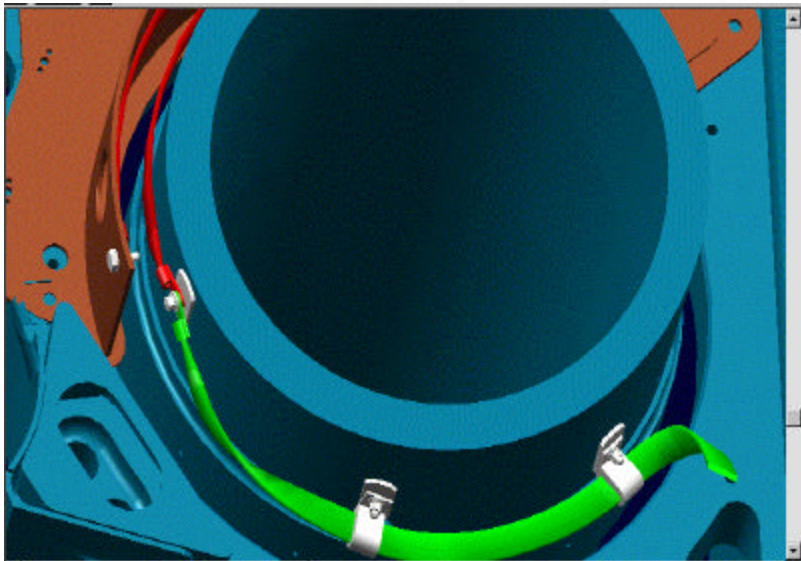
#10 Readiness Driver Bonding Straps

NACELLE TIP RIB
SPINDLE (TYPICAL
BOTH SIDES)

Nacelle Tip Rib Spindle Straps

- Investigating new material/designs and routing for straps as part as overall Nacelle Inspection task
- Bell revising Bell Standard 120-172 to correct the usage of the wrong size terminal lug for width of straps

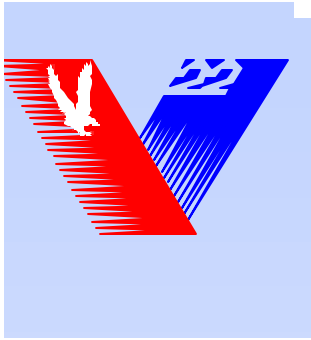
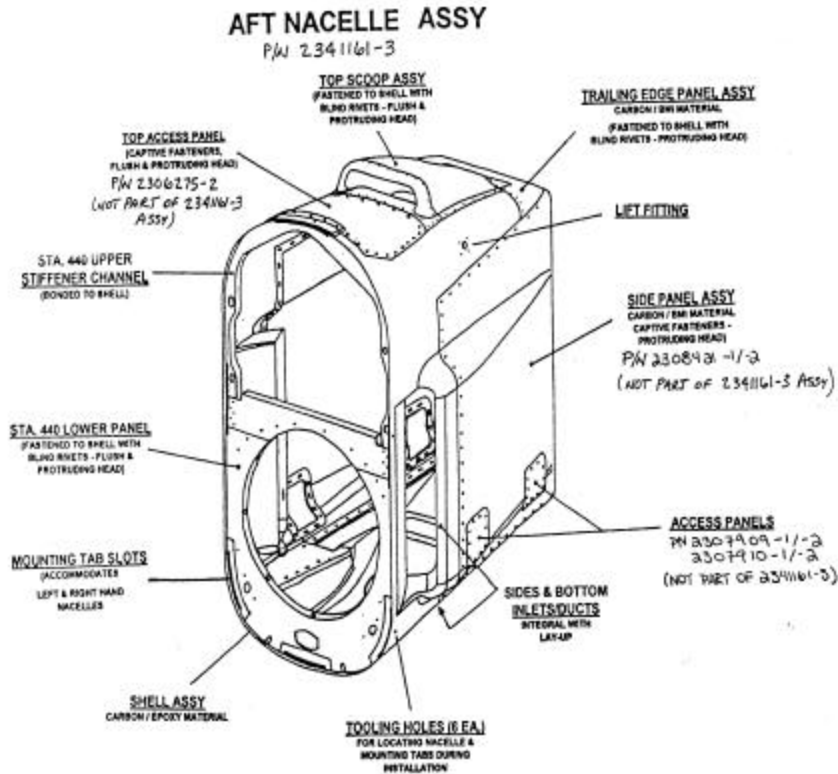
#11 Readiness Driver IRS TRANSITION PANEL

- Composite structural panels on IR suppressor are suffering heat and vibration damage.

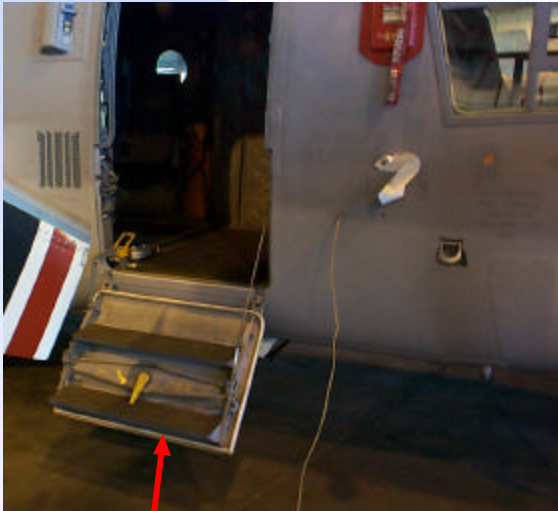
#12 Readiness Driver Lower Cabin Door

Lower Cabin Door
