Report of the Panel to Review the V-22 Program

April 2001

SUBJECT: Report of the Panel to Review the V-22 Program

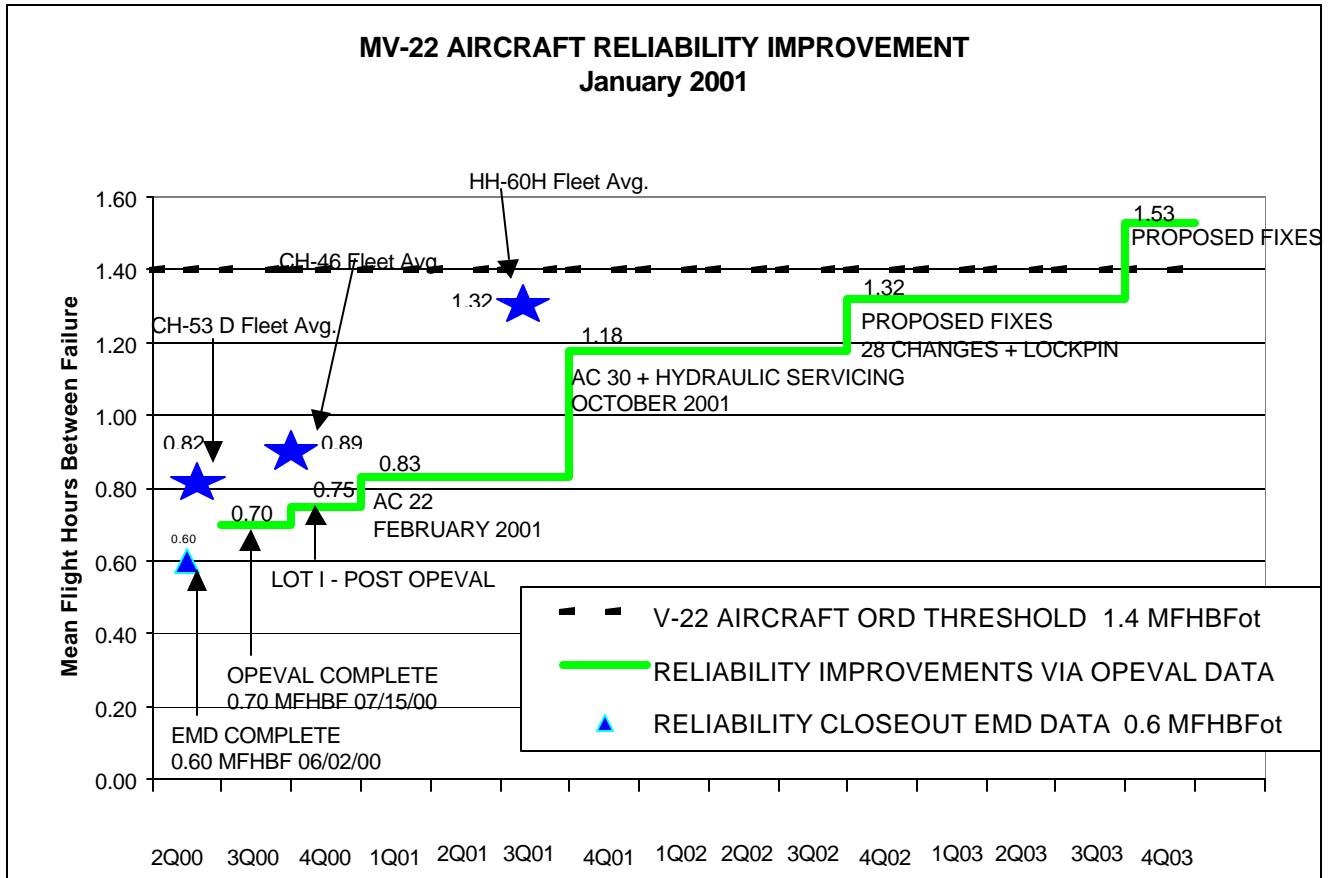
Figure 2: MV-22 Reliability Improvement Plan

The program has plans addressing all of the major reliability challenges, and a schedule showing the system meets the 1.4-hour threshold in 2003. Figure 2 shows the timeline and several of the important reliability initiatives in work to allow the aircraft to meet the MFHBF threshold.

The plan results in a 218 percent improvement in MFHBF performance. Of note is that the planned reliability upgrades only improve MFHBA from 18 to 23 hours, or 128 percent. This difference suggests that some amount of time and effort will be spent on reliability improvements that are not necessarily important to mission accomplishment.

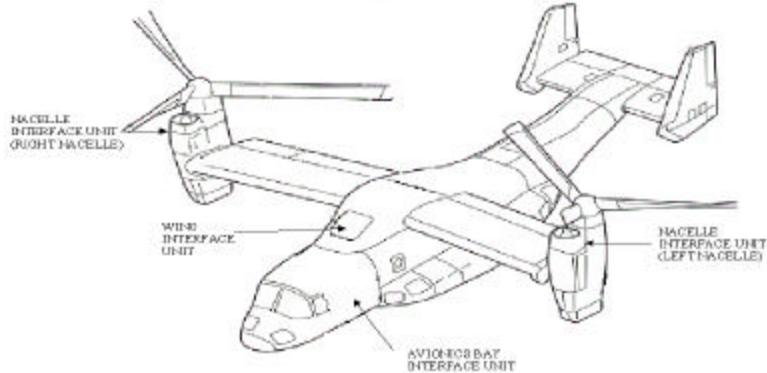
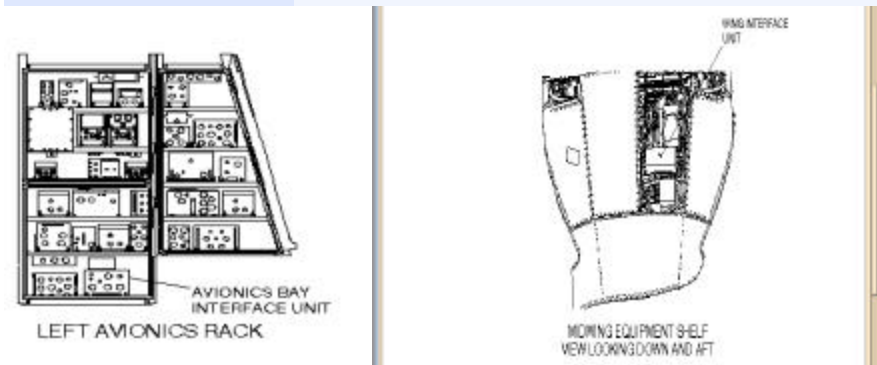
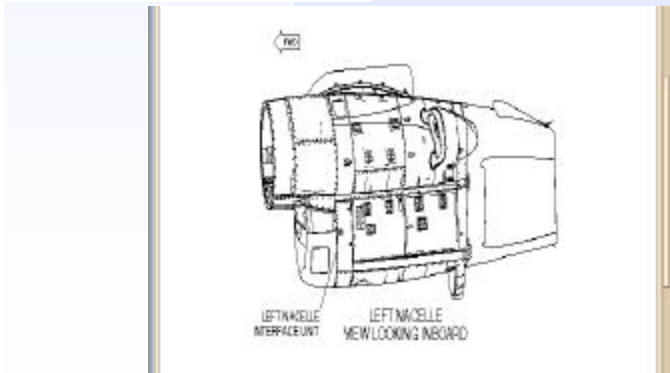
#9 Readiness Driver Interface Units

- IUs provide data bus interface for equipment not data bus compatible (MIL-STD-1553)
- Four IUs per aircraft (avionics bay, wing, 2 in nacelle)
